Impact of Attic Ventilation on Shingle Life

Roofing contractors report a 24% reduction in shingle service life and many documented problems in the field

By Paul Scelsi

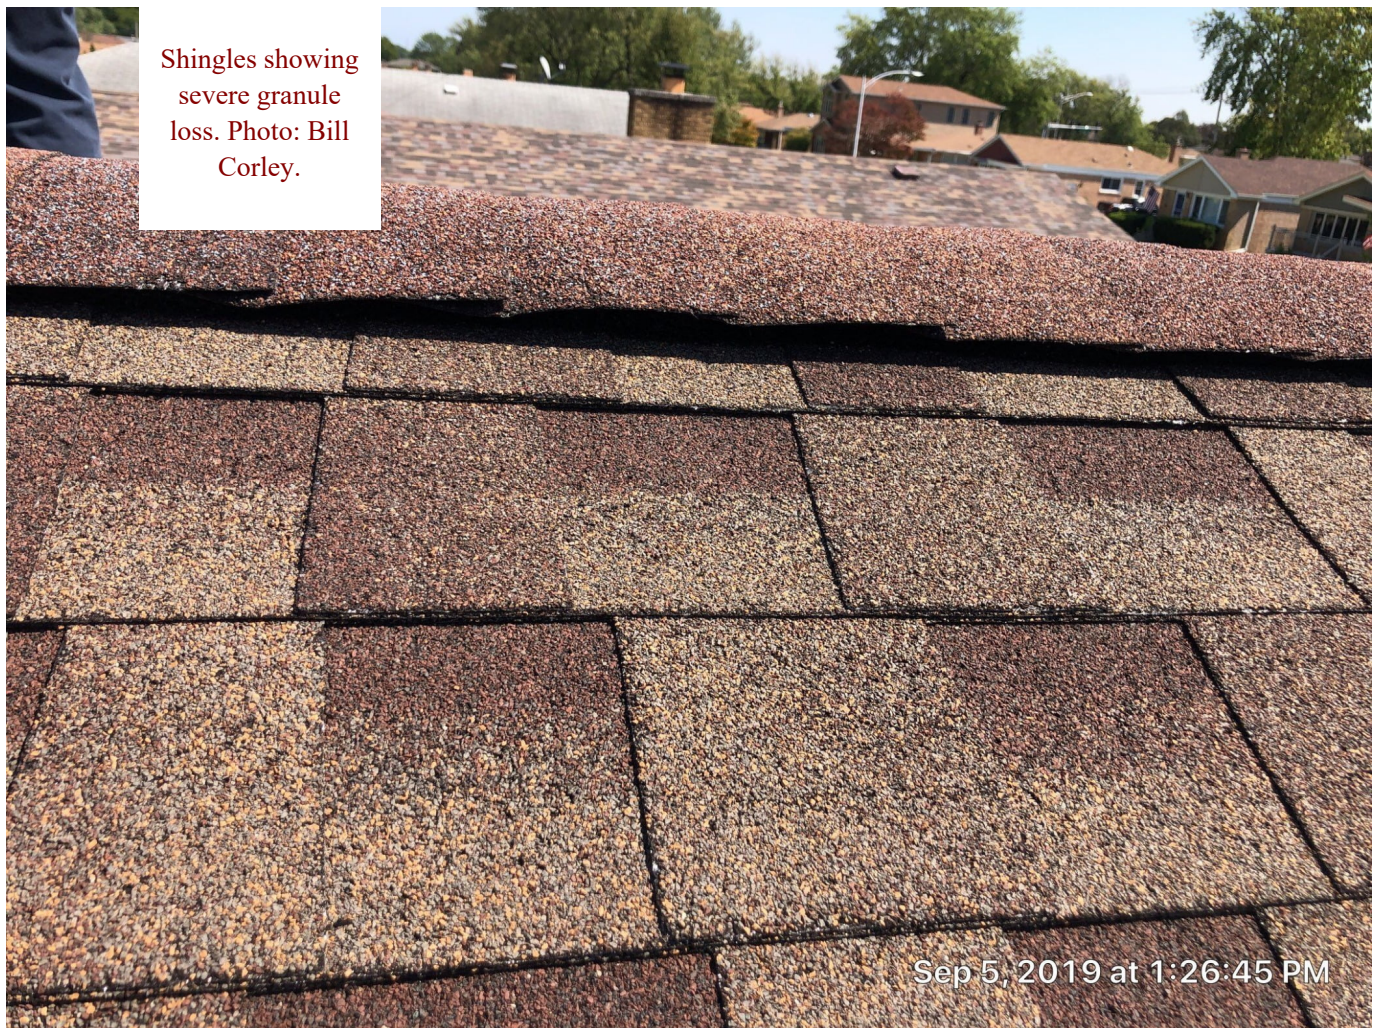
A wavy roof deck caused by zero vents. Photo: Sue May.

“We worked on a project with a house addition. The roof decking was wavy like a roller coaster. The decking was rotted and unsafe to walk on. There was zero attic ventilation,” said Sue McCollum May, owner/manager, A Better Way Construction & Roofing, Lincoln, Neb.

“The house had no attic ventilation. We installed ridge vent and soffit vents. It has helped cool the upstairs. Of course, we first had to replace the roof and the roof deck,” said May of A Better Way Roofing.

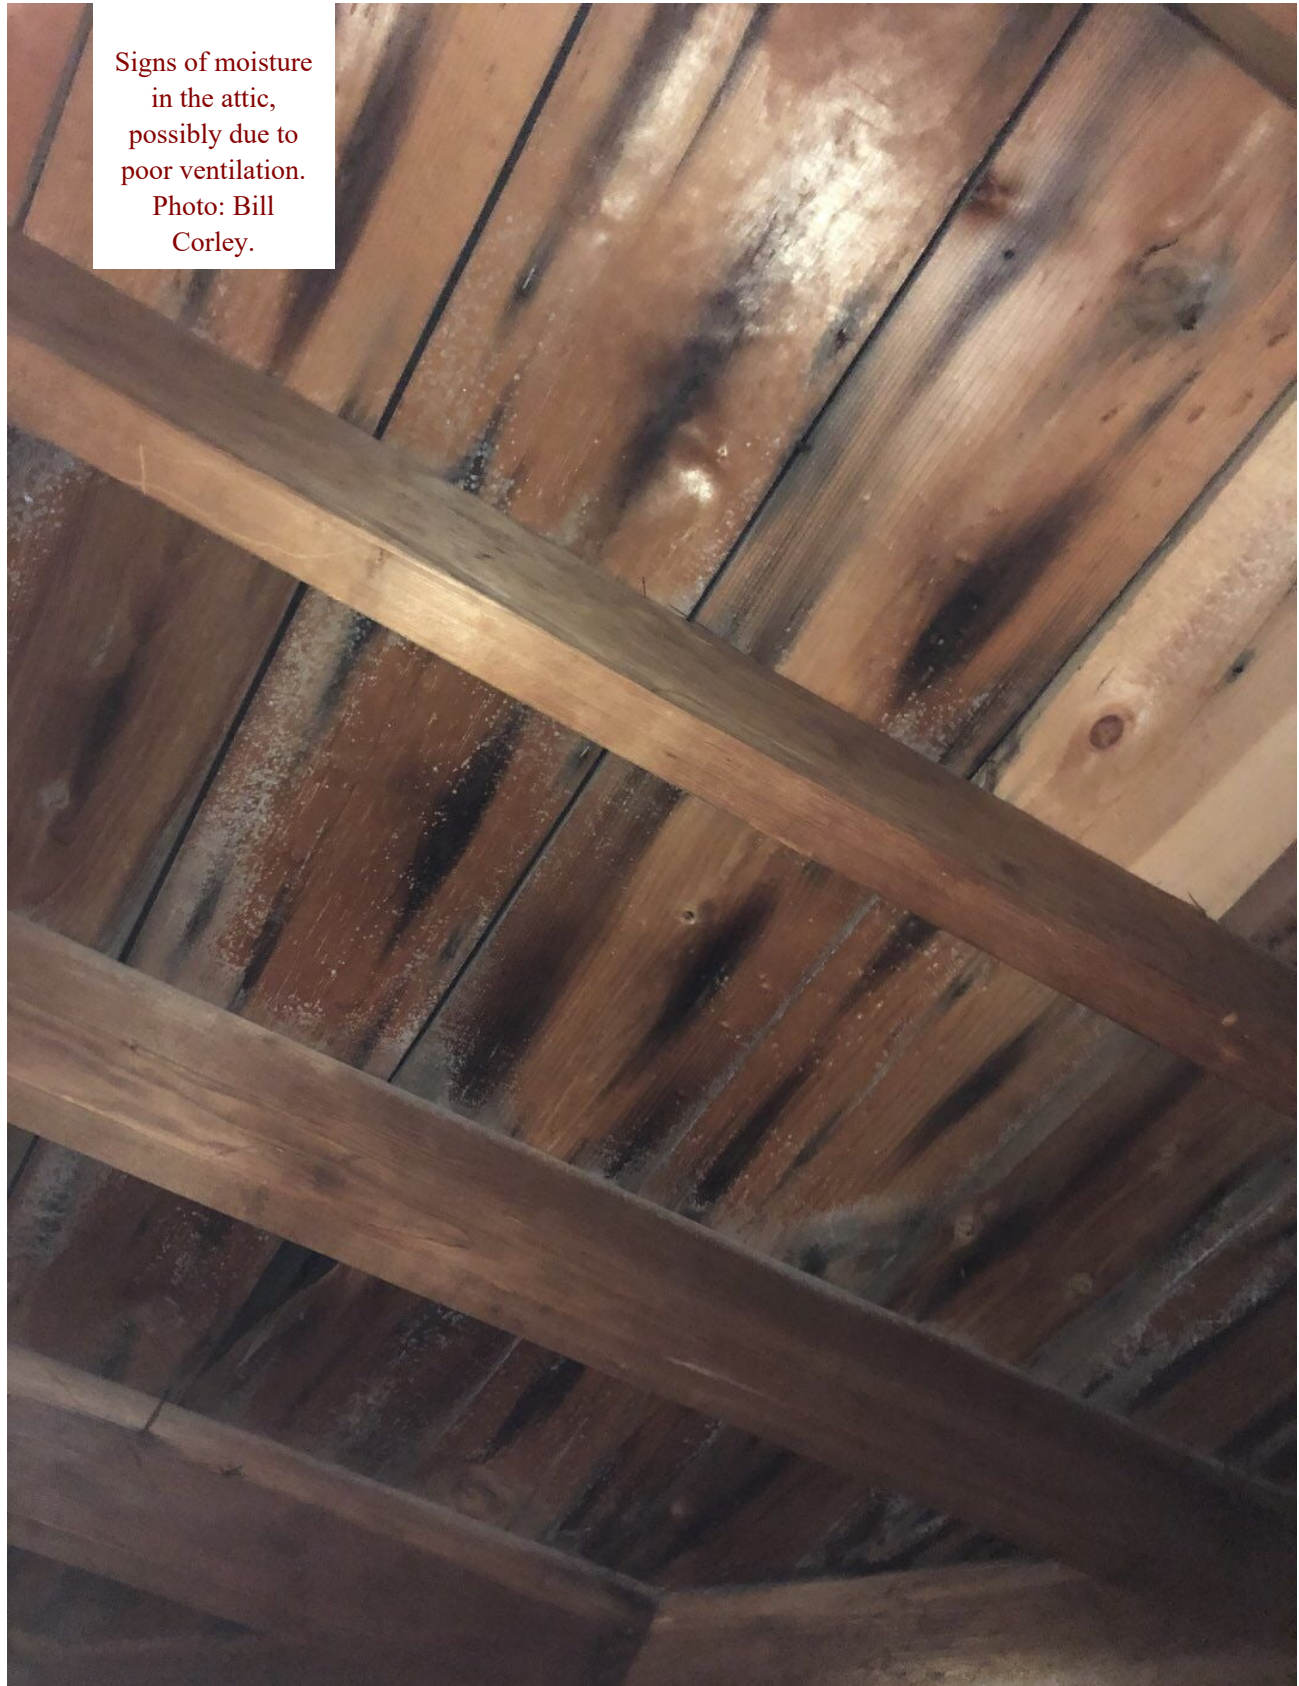
Signs of moisture
in the attic,
possibly due to
poor ventilation.
Photo: Bill
Corley.

“We found extreme granule loss, excessively premature,” said Corley. “We also found sweating on the inside creating moisture damage.”

“On that project with extreme shingle granule loss and sweating inside, the roof had a mesh roll ridge vent combined with a couple of mushroom vents low on the roof for intake (box vents that are designed to be exhaust, not intake),” said Corley of Style Exteriors by Corley. “We removed the mushroom vents and installed roof-top, shingle-over intake The Edge Vent. We then replaced the mesh roll ridge vent with the externally baffled ShingleVent II ridge vent. Now the new roof has continuous airflow low to high.”
