# Impact of Attic Ventilation on Shingle Life

Roofing contractors report a 24% reduction in shingle service life and many documented problems in the field

By Paul Scelsi

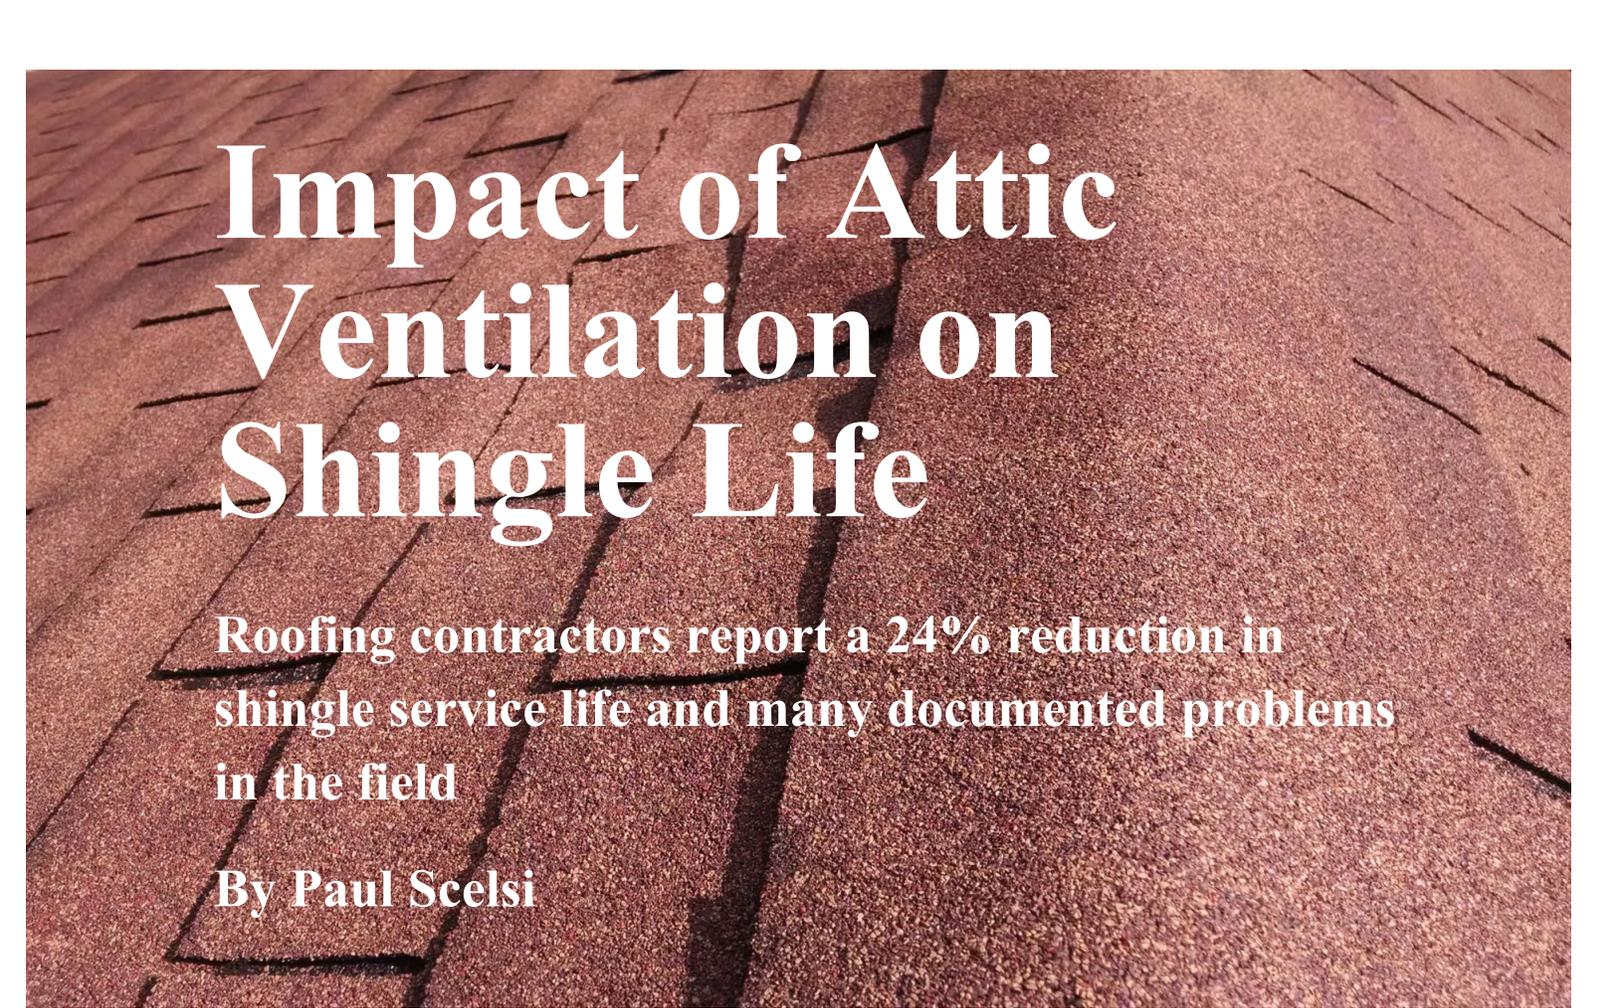
*A wavy roof deck caused by zero vents. Photo: Sue May.*

“We worked on a project with a house addition. The roof decking was wavy like a roller coaster. The decking was rotted and unsafe to walk on. There was zero attic ventilation,” said Sue McCollum May, owner/manager, A Better Way Construction & Roofing, Lincoln, Neb.

“The house had no attic ventilation. We installed ridge vent and soffit vents. It has helped cool the upstairs. Of course, we first had to replace the roof and the roof deck,” said May of A Better Way Roofing.
