PERFORMANCE TEST REPORT

AIR VENT, INC.

SERIES/MODEL: Hip Ridge™ Vent

Report No.: A3223.01-801-44
Start Test Date: 03/23/11
End Test Date: 03/24/11
Report Date: 04/25/11
Expiration Date: 03/24/21

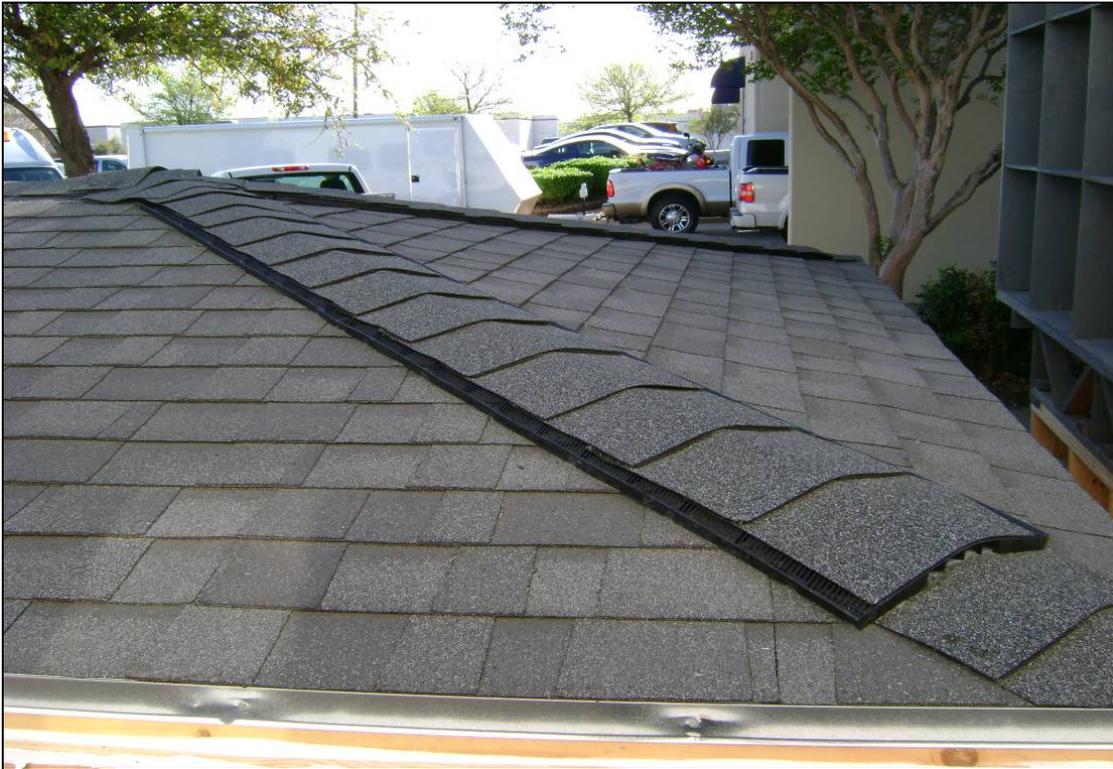
Photo No. 1: Specimen #1 - Wind stream 45° to vent prior to testing

Test #1: (Positioned 45° to wind stream)

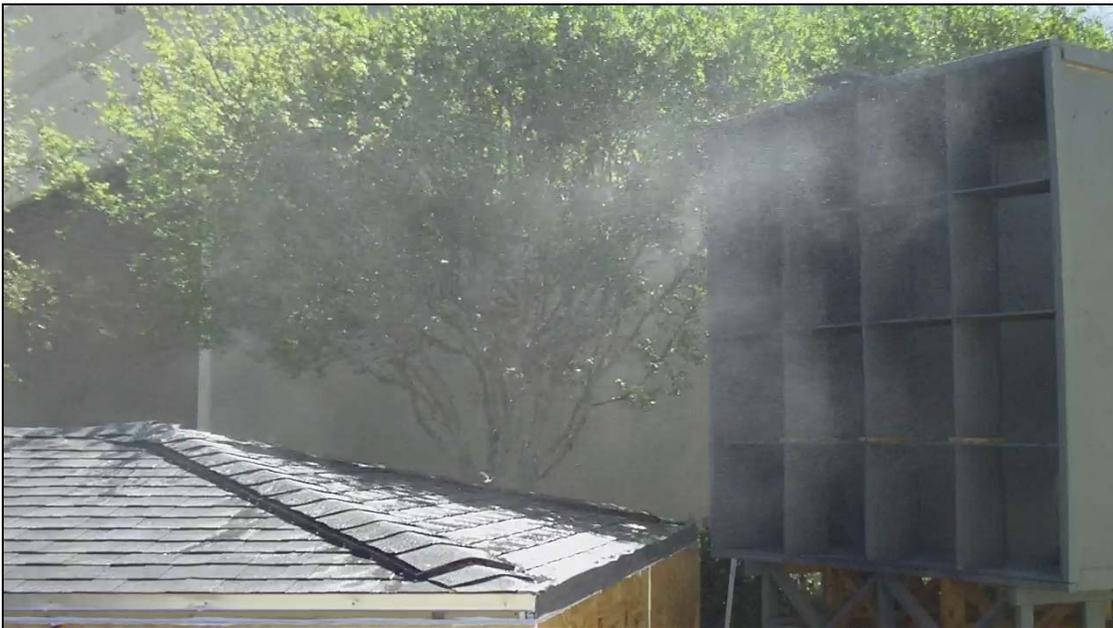
Photo No. 2: Specimen #1 - Wind stream parallel and perpendicular to vents

Test #2: (Positioned parallel to wind stream)

Test #3: (Positioned perpendicular to wind stream)

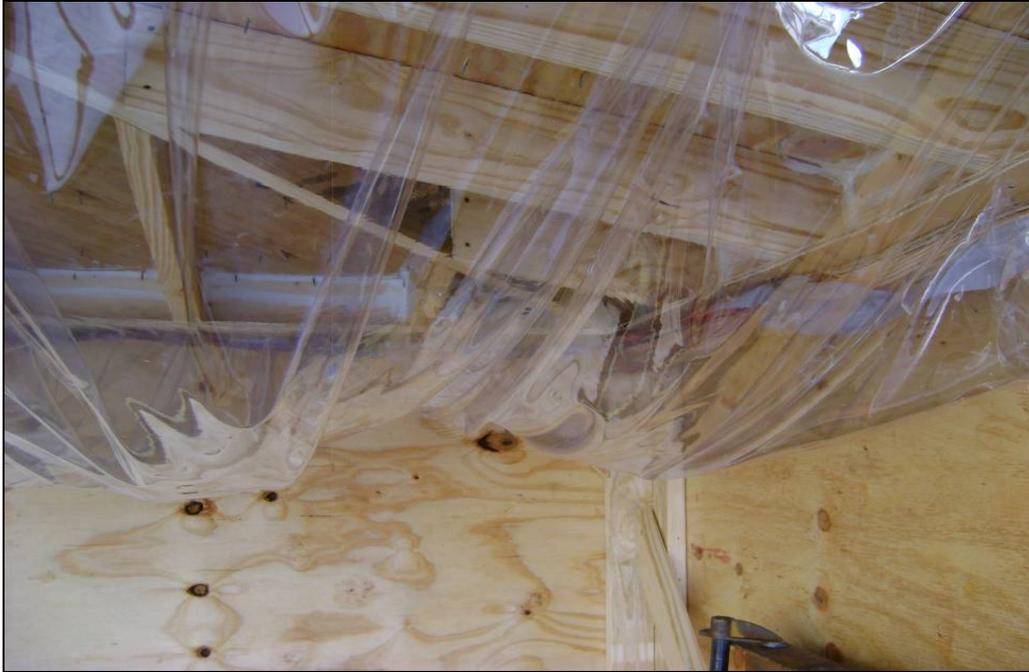
Photo No. 3: Water collection system under test deck at the conclusion of testing

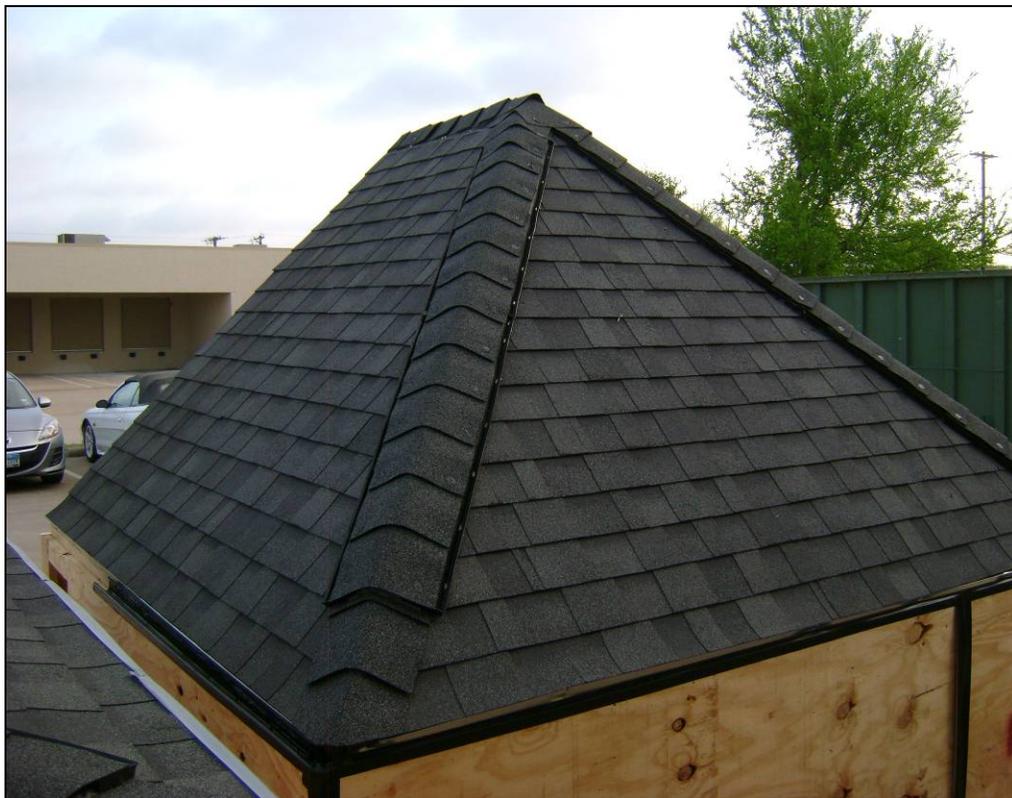
Photo No. 4: Specimen #2 - Prior to testing

Test Specimen #2: 12:12 pitch

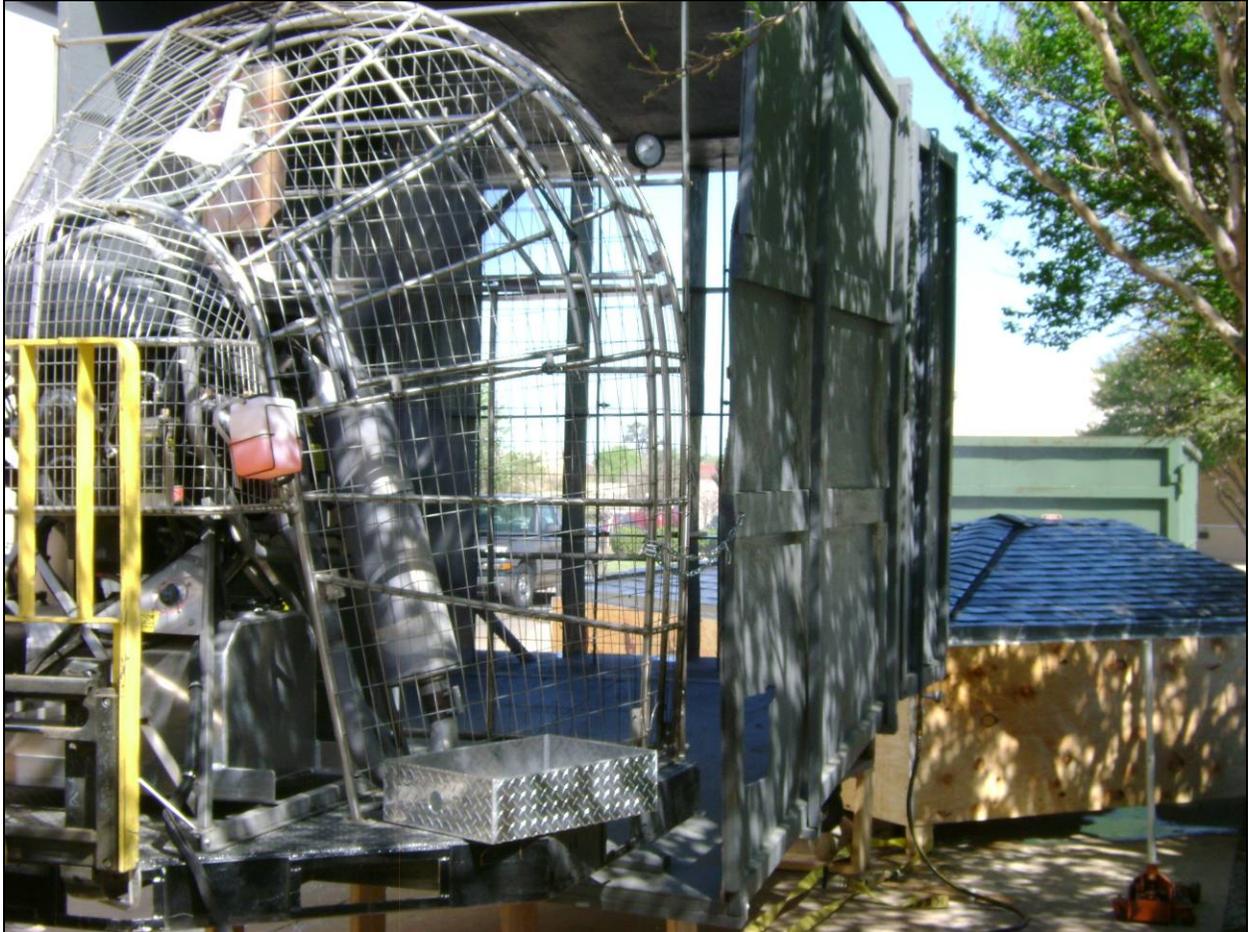
Photo No. 5: Wind generator and wind stream plenum (Specimen #1 in background)

Wind and Rain Supply: Gas engine-powered 7' diameter wind generator with calibrated water spray distribution system. Water spray was calibrated to 4.3 gallons per minute. Calibrated area is 8' x 8'.
